Technical Report ARWEC-TR-99002

**METALLURGICAL FAILURE ANALYSIS OF THE M230
MACHINE GUN BARREL – MIF-A-001-1999-I**

June 1999

U.S. ARMY ARMAMENT RESEARCH, DEVELOPMENT AND
ENGINEERING CENTER

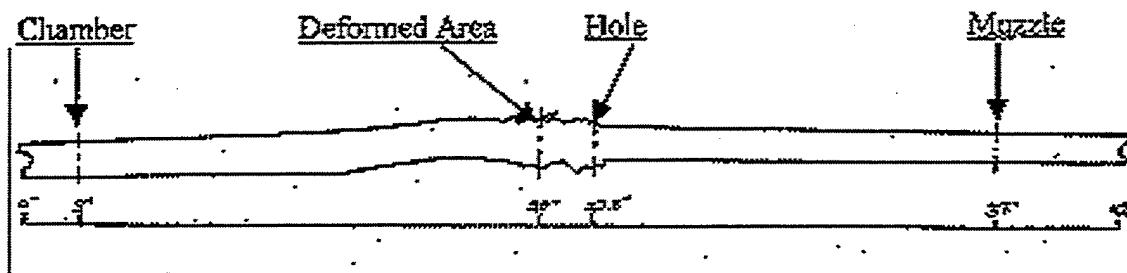
Figure 1
Outline of the failed barrel showing where metallurgical specimens were taken from

One half of the longitudinally sectioned barrel was used for metallographic analyses while the other half was left intact. Sections of the barrel wall were cut, as shown in figure 1, then mounted and polished. Hardness measurements were performed using the diamond pyramid hardness (DPH) tester and then a semi-quantitative chemical analysis was performed on the specimens using energy dispersive spectroscopy (EDS). Finally, the samples were etched using nital to reveal the microstructures. Micrographs were taken of the microstructures using a light microscope/metallograph.

The microstructure and hardness in four areas of the barrel were examined to look for differences and changes to the original structure and hardness. The four areas analyzed were the muzzle end, through the large hole, a deformed area near the hole and the chamber end (fig. 1). Drawing no. 387-3116 calls out a maximum barrel hardness of 33 Rockwell C. Past work performed by the Failure Analysis Team at ARDEC has shown that the microstructure of the barrel is typically a tempered martensite (ref. 3).

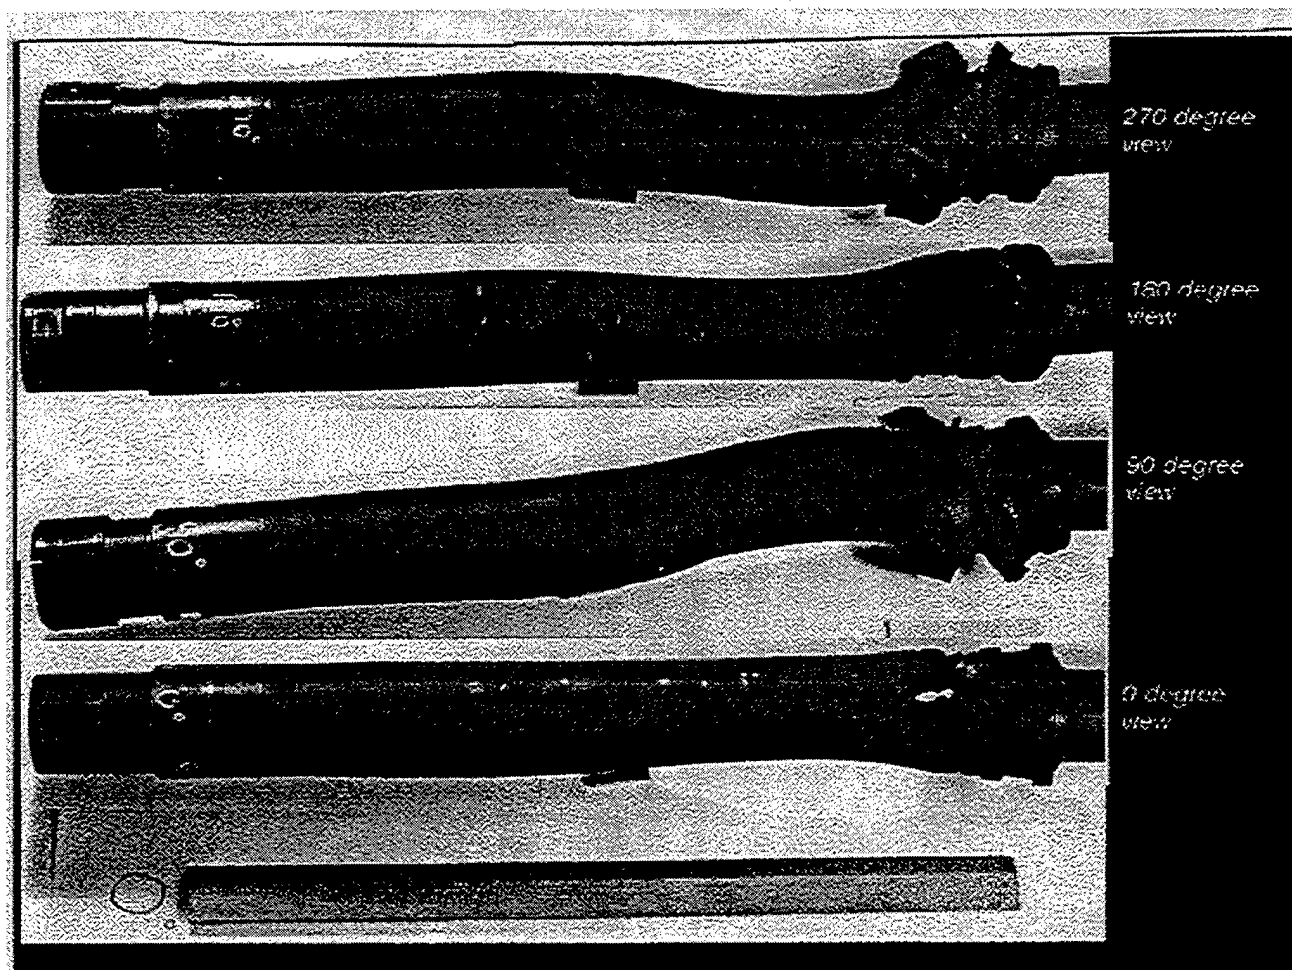
Figure 2
Chamber-end of the barrel, 360 deg view

Figure 2 shows photographs of the barrel from the chamber end to just beyond the end of the remaining barrel support (or shroud). The barrel is severely deformed and there are two puncture holes that can be seen in the 0 deg view and the 180 deg view.

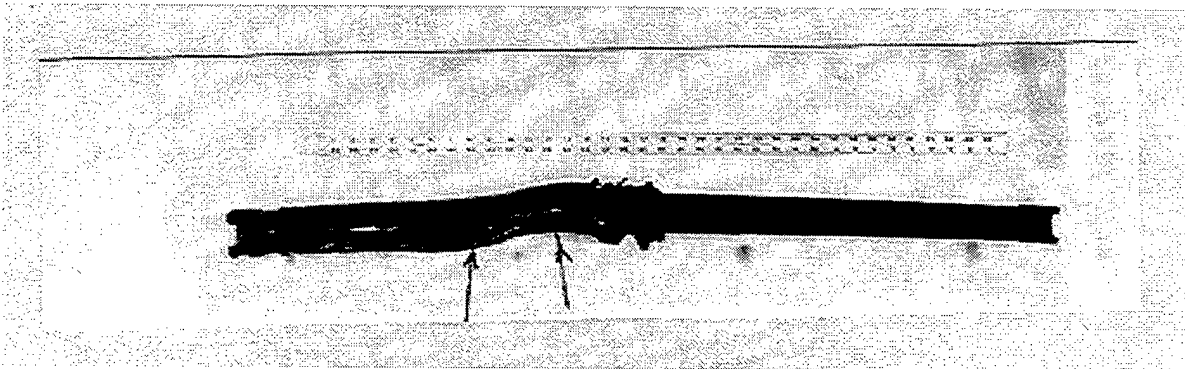
Figure 3
Sectioned M230 barrel

A photograph of the barrel after it had been cut along its entire length is shown in figure 3. In addition to the lack of rifling between 8.5 to 21 in. from the chamber end, yielding and deformation of the barrel material was noted, see arrows. At 10.5 in. from the chamber, the wall thickness dropped down to 0.30 in. where it is normally about 0.50 in.

The fracture surfaces at the holes, where the projectiles exited, were examined. The fracture surfaces were pointed and the material was elongated nearly 100%. No brittle fracture surfaces or tensile dimples were noted. Tensile dimples are seen when a material exceeds its room temperature tensile strength. This suggests that the material did not fail due to a void or other manufacturing defect but rather from overheating, which caused it to lose most of its tensile strength yet increased its plasticity properties.

Arrows point to areas where the material has yielded.

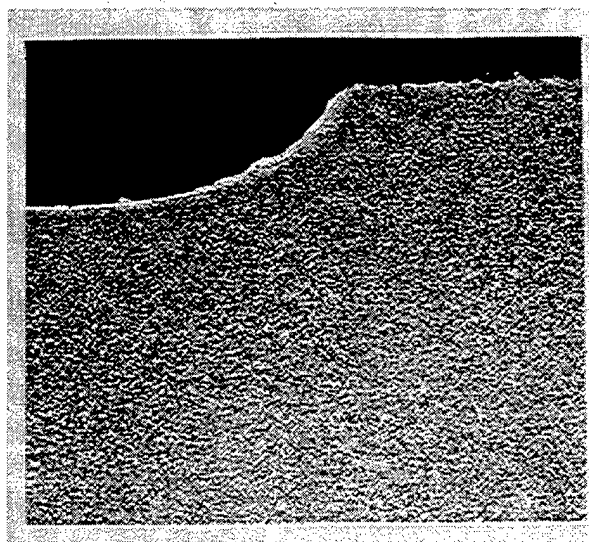
b
Magnification, 42.6x

Figure 5b (50x mag., hardness 36 Rockwell C) was taken at a low magnification to show whether the microstructure in the lands and grooves had changed due to heat. No changes are seen. Figure 5c shows this same area at high magnification, 500x. This is a mixed microstructure and the hardness is a little high per the drawing.

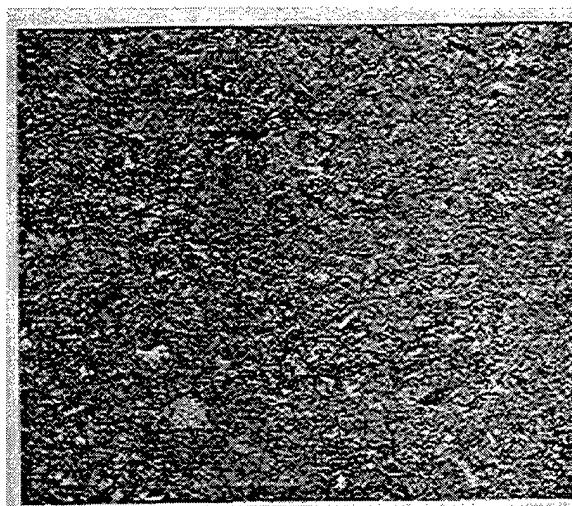
d
Magnification, 426x

Figure 5d (500x mag., hardness 30 Rockwell C) is the microstructure from the mid-wall of the muzzle region. This is a tempered martensite structure which is typical for the M230 barrel. The hardness is appropriate per the drawing.

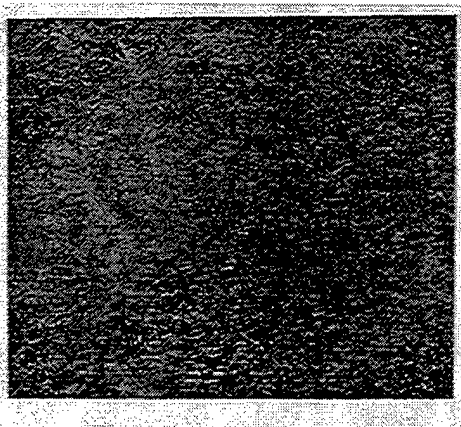
c
Magnification, 350 x

Figure 6c (500x, 53 Rockwell C) is the microstructure of the bullet exit hole. This microstructure contains bainite and untempered martensite. The presence of bainite and untempered martensite coupled with an increase in hardness from 30 to 36 Rockwell C to 53 Rockwell C can only be accomplished by heating the steel above its austenitizing temperature (~1,400°F) and then quenching. Not all areas of the gun barrel wall achieved temperatures as high or higher than 1,400°F. Some areas on the outer diameter only got warm enough to be further tempered, such as the area in figure 6d.

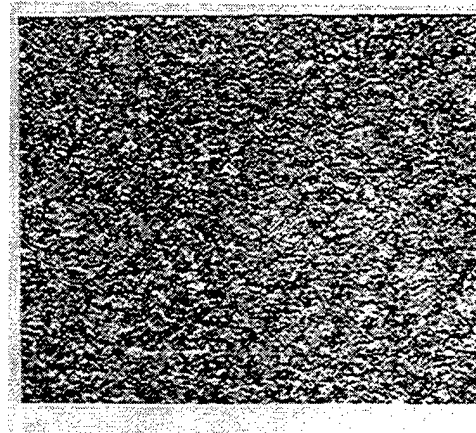
d
Magnification, 350x

Figure 6d (500x, 27 Rockwell C) is a microstructure from the mid-wall. Compare it to figure 5d and contrast it to figure 6c. This structure is a coarse, tempered martensite. However, the hardness has dropped from 30 Rockwell C (as measured in the mid-wall of the muzzle) to 27 Rockwell C. For the hardness to drop as such, this area only got heated (or tempered) to about 1,200°F. This area did not go over the austenitizing temperature of 1,390°F and then get quenched.

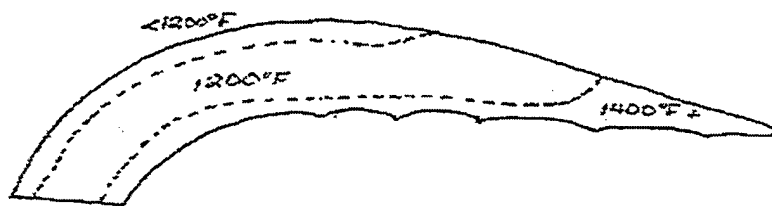
Figure 6e shows the temperature profile of this area at the time of failure. At the exit hole and along the lands and grooves, the temperature exceeded 1,400°F. The mid-wall is shown reaching a temperature of 1,200°F while the outer diameter of the barrel stayed below a temperature of 1,200°F.

e
Temperature profile of the cross-section of the hole region at the time of failure

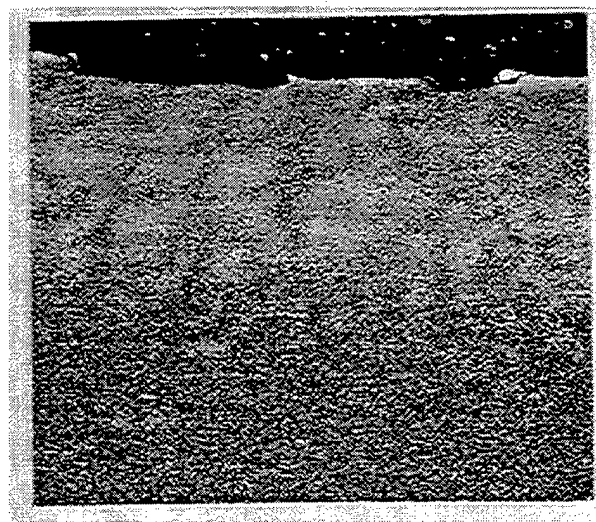
b
Magnification, 42.6x

Figure 7b (50x, 54 Rockwell C) is a low magnification photograph of the lands and grooves area. The microstructure has changed due to heat in this area, as is evidenced by the presence of both the white and dark areas. Figure 7c is the same area at high magnification. Again, as in figure 6c where the hole was located, bainite and untempered martensite are observed. This area also, exceeded the austenitizing temperature and then was quenched in air to achieve this structure and hardness.

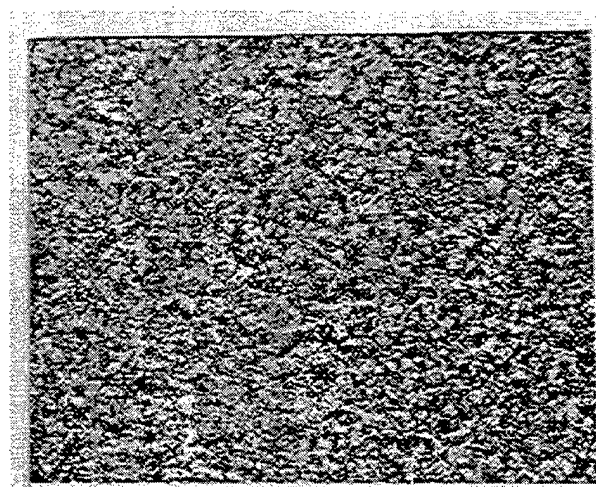
d
Magnification, 426x

Figure 7d (500x, 34.5 Rockwell C) is the mid-wall area of the deformed area. This is a mixed microstructure and it is not clear what effect the heat had on this area.

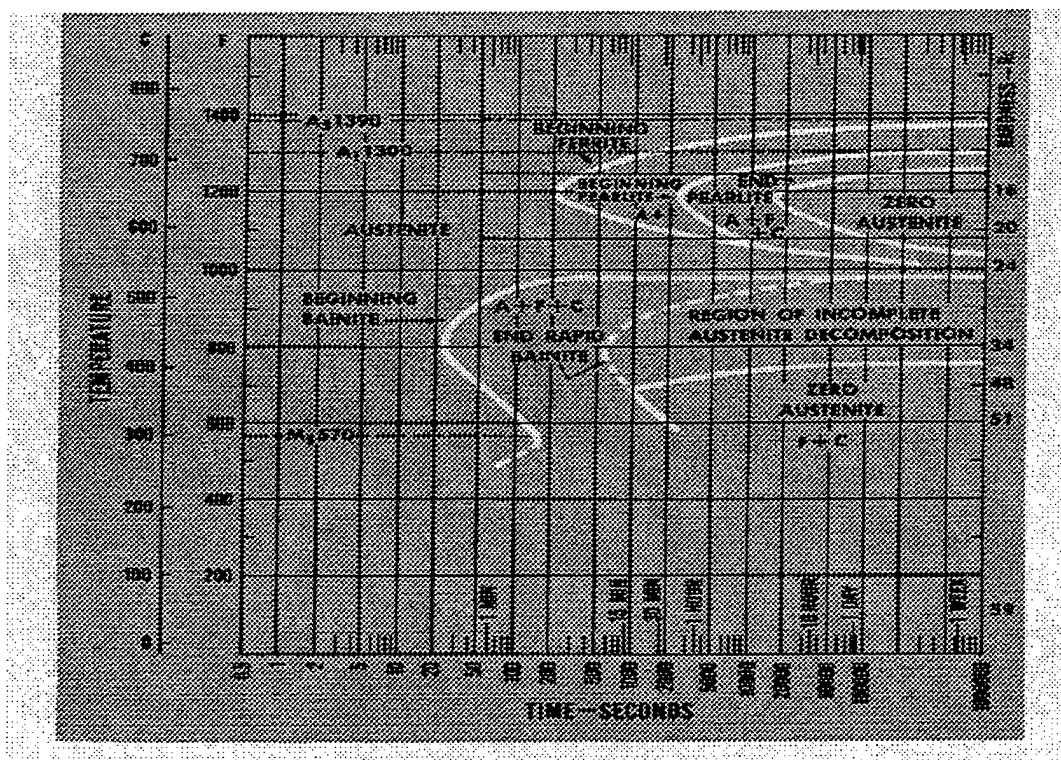
Figure 9
Transformation temperature versus time for medium carbon alloy steels^a

The change in the microstructures from tempered martensite to bainite and untempered martensite coupled with the increase in hardness values seen at the holes where the projectiles exited, supports the theory that the gun barrel steel exceeded the austenitizing temperature and then air cooled. A transformation temperature versus time (TTT) diagram is shown in figure 9. This diagram shows that the austenitizing temperature is 1390°F. The barrel may have gotten hotter than 1390°F, but with the various temperatures throughout the barrel and the subsequent variable quenching rates, it is difficult to pin down exactly how hot the barrel got in different areas.

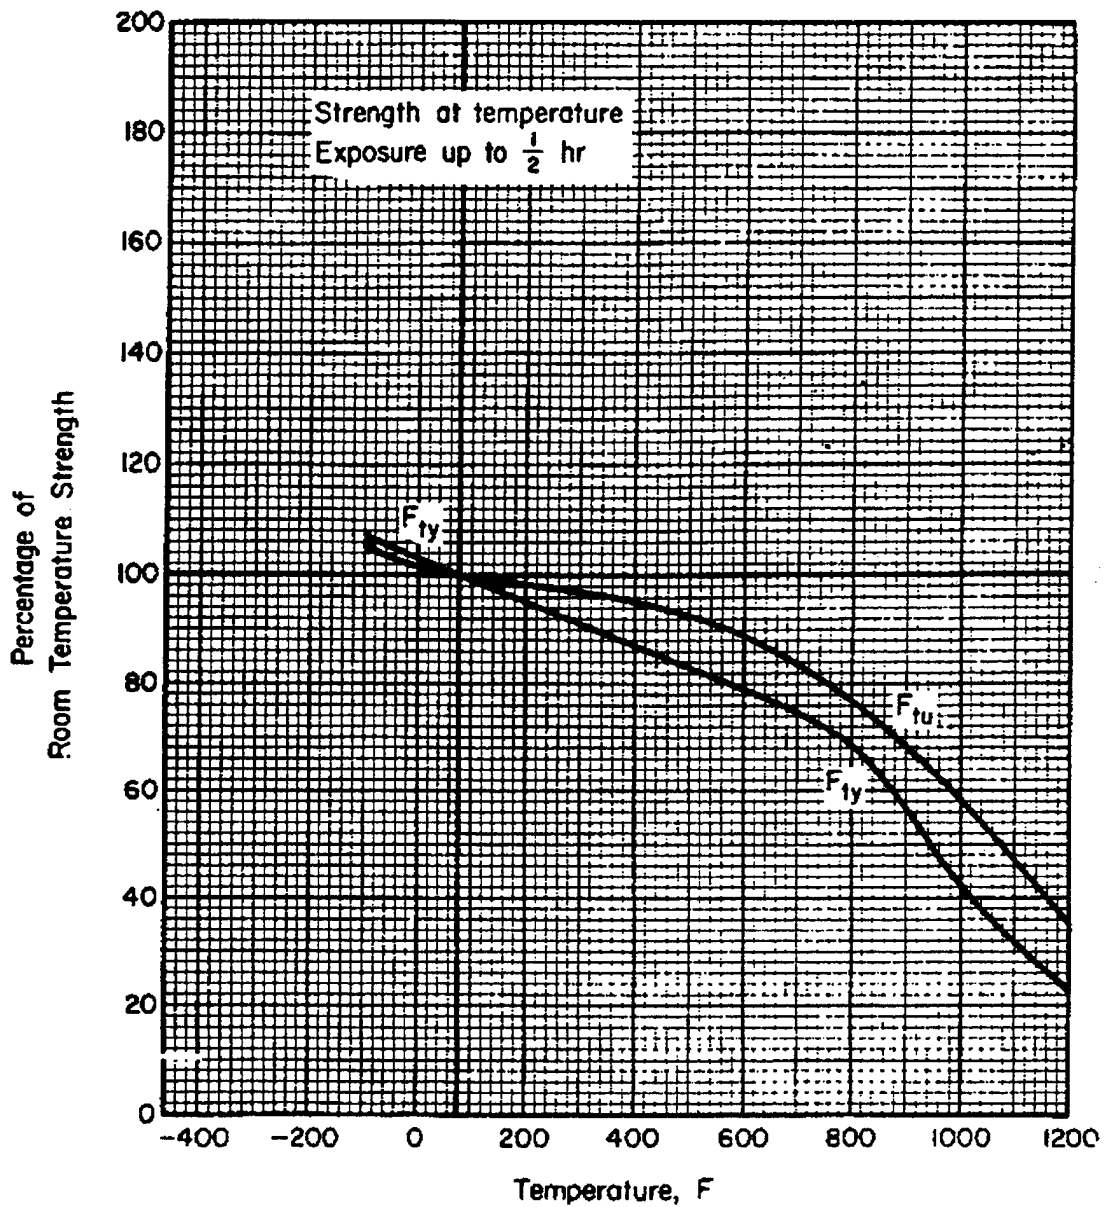
Figure 10
Effect of temperature on the tensile ultimate strength (F_{tu}) and tensile yield
Strength (F_{ty}) of AISI low-alloy steels (all products)

Once the barrel steel exceeds the austenitizing temperature, the hot tensile strength plummets (fig. 10). This diagram shows that at 1200°F, the barrel steel has only 35% of the room temperature ultimate tensile strength. Room temperature strength values are given in table 1. Thus, at 1,200°F the yield strength of the steel is 40 ksi maximum with the chances being that the yield strength is actually far lower than that at the austenitizing temperature of 1,390°F.
